Inspection report for the property at

# Northern

This report is prepared exclusively for **Dan**  
Inspected On: **27-05-2025**

**Brand of RV:** 2020 Primetime Sanibel Wide Body

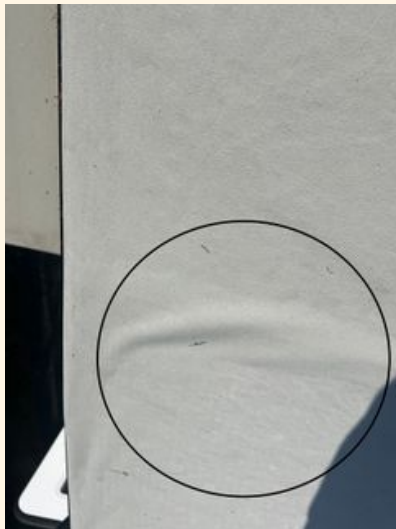
*Air bubble in the middle of the roof on the curbside of the RV.*

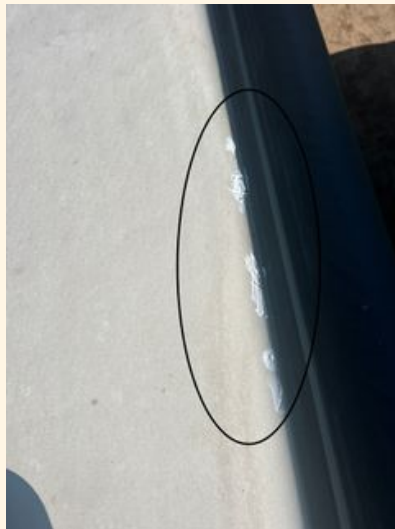
*The holes in the membrane were temporarily repair with Dicor*

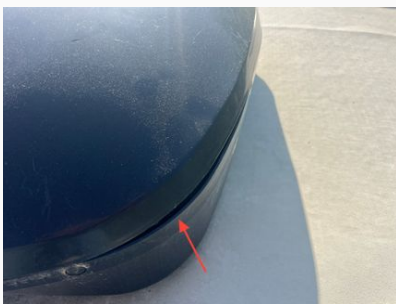
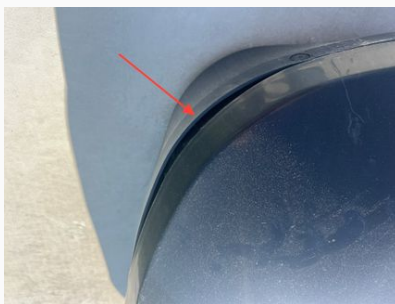
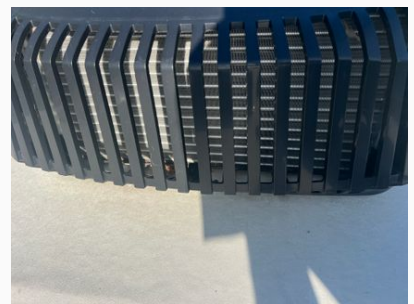
**🚩 (RE-2) Major Issue:** *There are gaps in both the Aircon cover joints. It is recommended that this be evaluated by a qualified RV Technician as this may allow water intrusion.*

*Gaps on the front joints of the Aircon covers.*

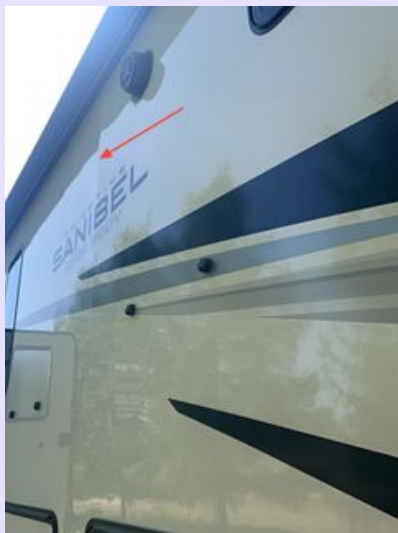
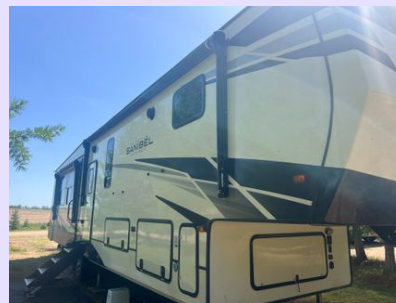
🔧 **(ES-1) Minor Issue:** There are two lines, top to bottom, on the curbside of the RV, at the S and B of Sanibel. These marks cannot easily be seen on a picture. It is recommended that this be further evaluated by a qualified RV Technician.

- ✂ **ES-1 Exterior Sidewalls - Curbside - Sidewall:** There are two lines, top to bottom, on the curbside of the RV, at the S and B of Sanibel. These marks cannot easily be seen on a picture. It is recommended that this be further evaluated by a qualified RV Technician.

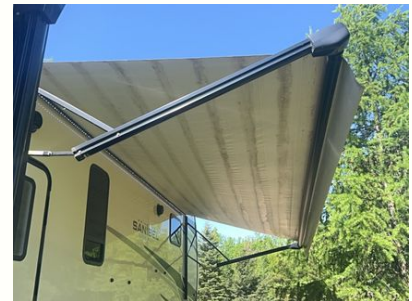
Underside of the Awnings are discolored. It is recommended a qualified RV Technician evaluate the awnings.

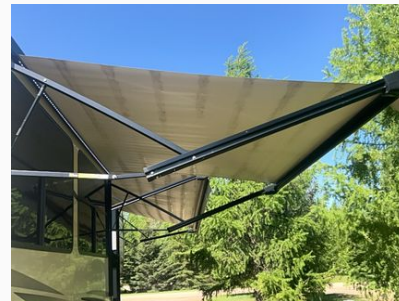
*Discoloration on the inside of the awning.*

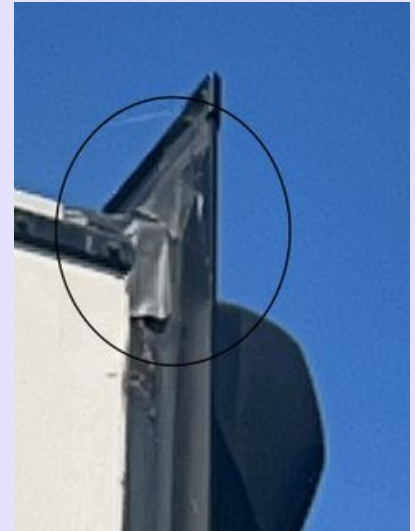
There are loose tapes on the slide out T- moldings. It is recommended that this be repaired by a qualified RV Technician.

*Tape at the top end of the T-moldings is detaching. This needs to be evaluated by a qualified RV Technician. [OBJ]*

- ✂ **S-1 Slideouts - Curbside Rear Slideout:** There are loose tapes on the slide out T- moldings. It is recommended that this be repaired by a qualified RV Technician.

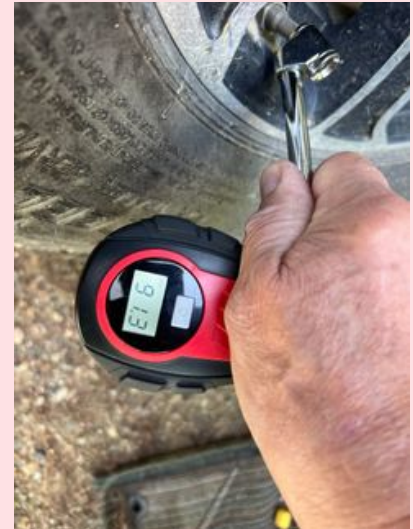
Curbside Front Wheel.

The curbside, front tire is 19 PSI below the RV Manufacturer's recommended tire pressure. **This is a LIFE SAFETY issue.** It is recommended that this be further evaluated by a qualified tire specialist prior to the RV being driven.

- ⚠️ **TW-1 Tires and Wheels - Curbside Front-Tire/Wheel:** The curbside, front tire is 19 PSI below the RV Manufacturer's recommended tire pressure. **This is a LIFE SAFETY issue.** It is recommended that this be further evaluated by a qualified tire specialist prior to the RV being driven.

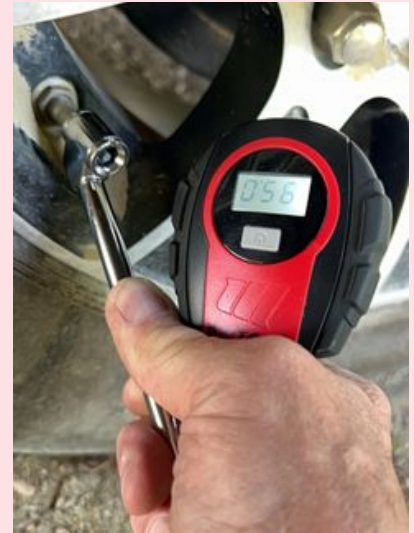
*Curbside rear wheel*

The curbside, rear tire is 15 PSI below the RV Manufacturer's recommended tire pressure. **This is a LIFE SAFETY issue.** It is recommended that this be further evaluated by a qualified tire specialist prior to the RV being driven.

- ⚠️ **TW-2 Tires and Wheels - Curbside Rear Tire/Wheel:** The curbside, rear tire is 15 PSI below the RV Manufacturer's recommended tire pressure. **This is a LIFE SAFETY issue.** It is recommended that this be further evaluated by a qualified tire specialist prior to the RV being driven.

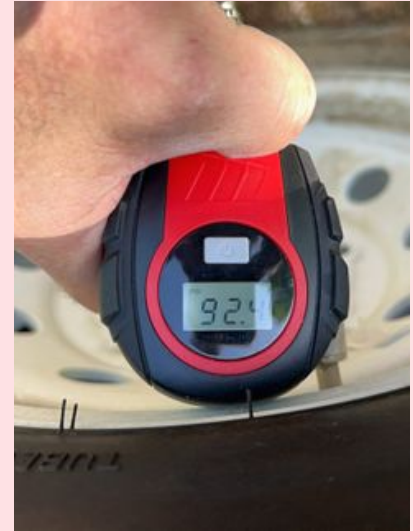
The streetside, rear tire is 18 PSI below the RV Manufacturer's recommended tire pressure. **This is a LIFE SAFETY issue.** It is recommended that this be further evaluated by a qualified tire specialist prior to the RV being driven.

- ⚠️ **TW-3 Tires and Wheels - Streetside Rear Tire:** The streetside, rear tire is 18 PSI below the RV Manufacturer's recommended tire pressure. **This is a LIFE SAFETY issue.** It is recommended that this be further evaluated by a qualified tire specialist prior to the RV being driven.

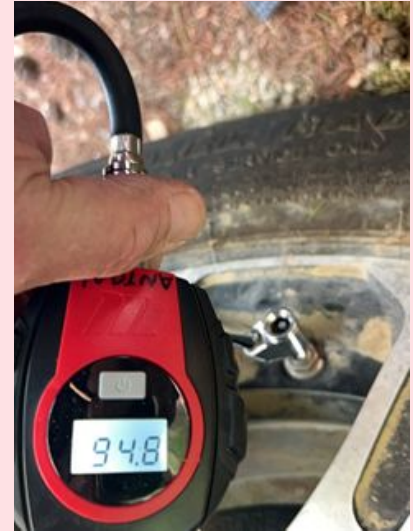
*Street side Front wheel*

The streetside, front tire is 15 PSI below the RV Manufacturer's recommended tire pressure. **This is a LIFE SAFETY issue.** It is recommended that this be further evaluated by a qualified tire specialist prior to the RV being driven.

- ⚠️ **TW-4 Tires and Wheels - Streetside Front-Tire/Wheel:** The streetside, front tire is 15 PSI below the RV Manufacturer's recommended tire pressure. **This is a LIFE SAFETY issue.** It is recommended that this be further evaluated by a qualified tire specialist prior to the RV being driven.

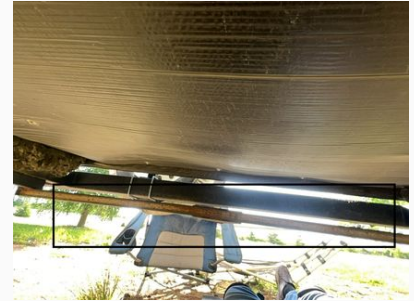
*Towbar shows signs of rust.*

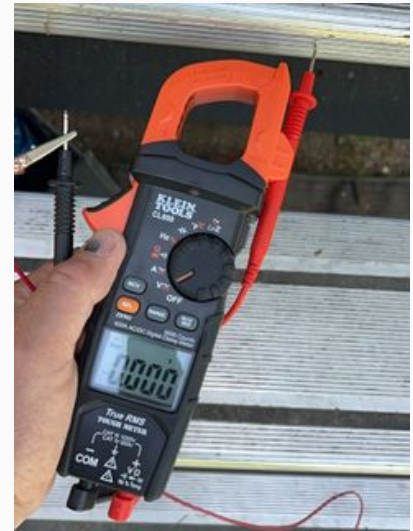
*Zero voltage*

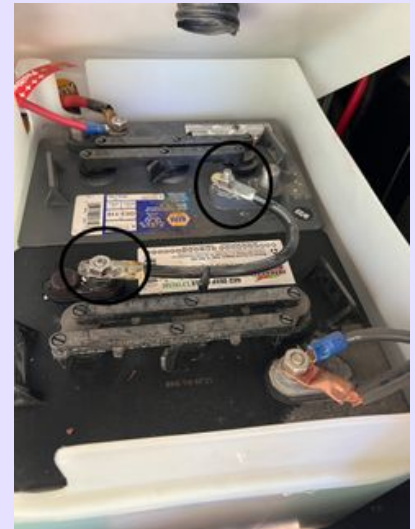
There is corrosion on Battery Terminals. It is recommended that this be evaluated by a qualified RV Technician.

*House Batteries: The terminals between the two house batteries has some corrosion. It is recommended that this be evaluated by a qualified RV Technician.*

- ✂ **1VA1VDES-1 120 Volt AC and 12 Volt DC Electrical System - 12 Volt DC House Battery:** There is corrosion on Battery Terminals. It is recommended that this be evaluated by a qualified RV Technician.

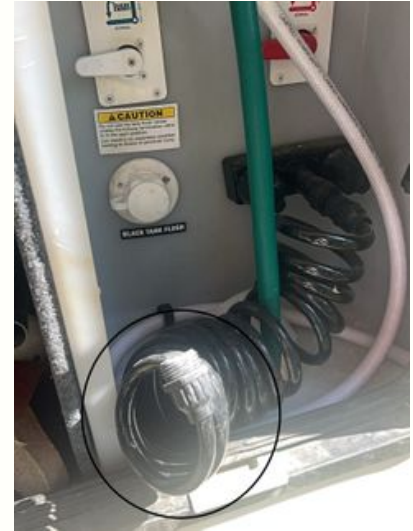
☆ (WS-1) Notice / Comment:  
No outside shower head installed.

*No shower head installed*

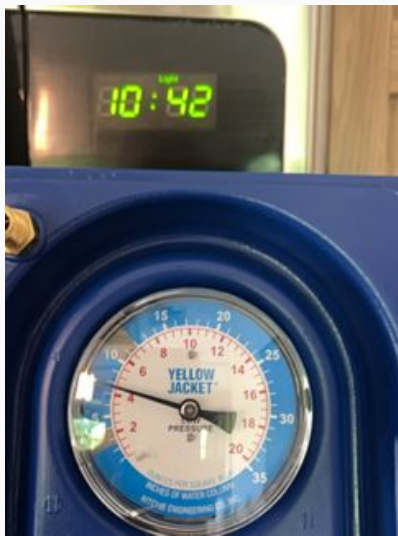
*Start time: 10.42 - 8" Water Pressure*

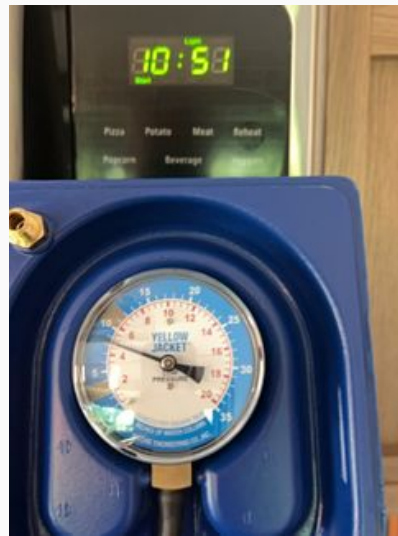
*End time 10.51 - 8" Water Pressure*

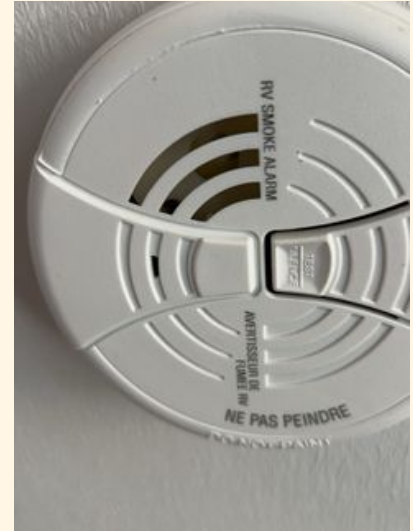
Smoke Detector battery was replaced during the inspection. It is recommended that the smoke detector is checked every 6 months.

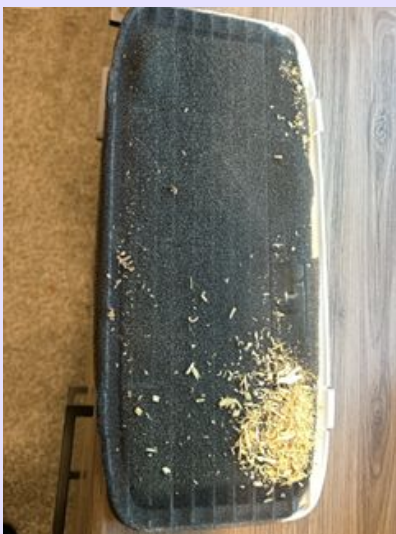
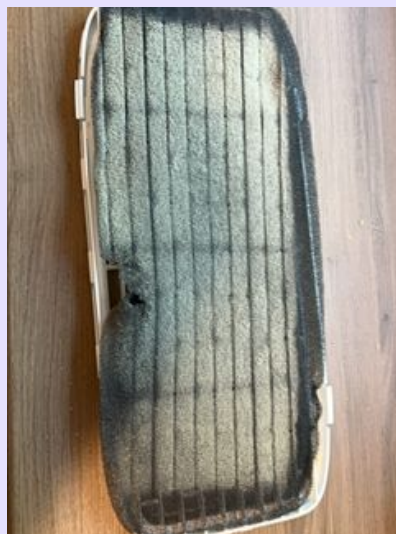
**(AAC-1) Minor Issue:** The inspector observed that the air conditioner filters were dirty. Dirty AC filters can affect the AC's ability to cool the coach. It is recommended that a qualified RV Technician evaluate this.

*Aircon Filters*

*Air conditioning filter*

- ✂ **AAC-1 Appliances: Air Conditioners - Air Conditioners - Front:** The inspector observed that the air conditioner filters were dirty. Dirty AC filters can affect the AC's ability to cool the coach. It is recommended that a qualified RV Technician evaluate this.

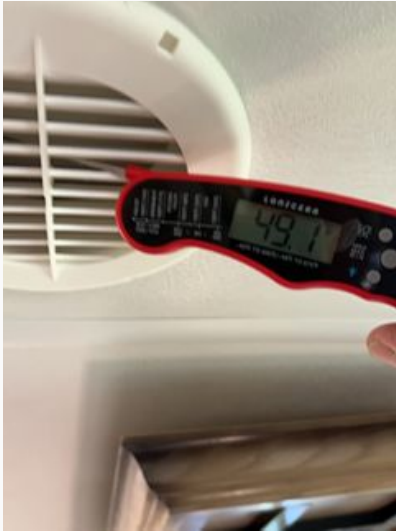
*Air Outlet temperature 49.1F*

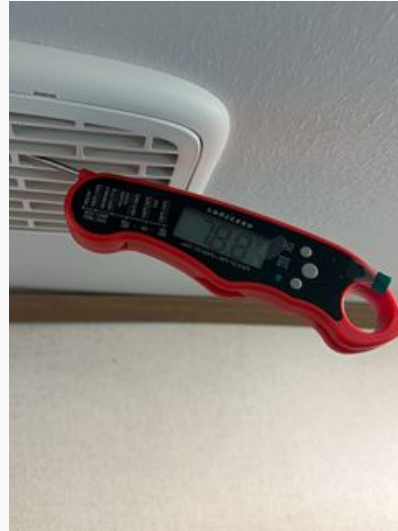
*Air Inlet temperature 79.8F*

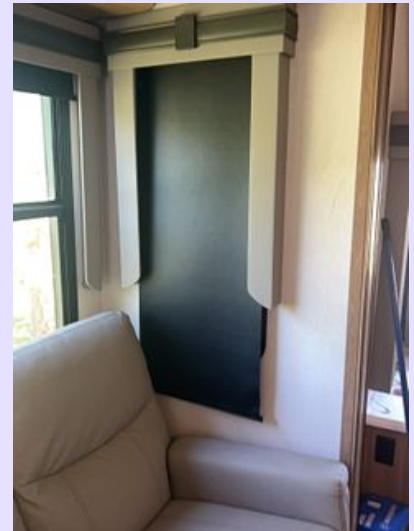
The Window covering, left-side of the right recliner, does not withdraw. It is recommended that this be repaired by a qualified RV Technician.

*The Window cover beside the recliner.*

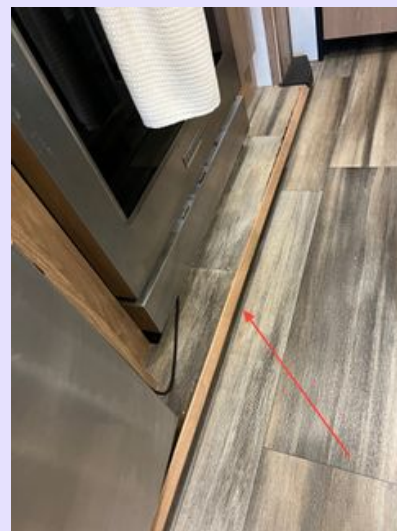
The Floor Trim under the Range and the Refrigerator is loose. It is recommended that this be reattached by a qualified RV Technician.

*Trim under the Range and the Refrigerator.*

- ✂ **I-3 Interior - Flooring:** The Floor Trim under the Range and the Refrigerator is loose. It is recommended that this be reattached by a qualified RV Technician.

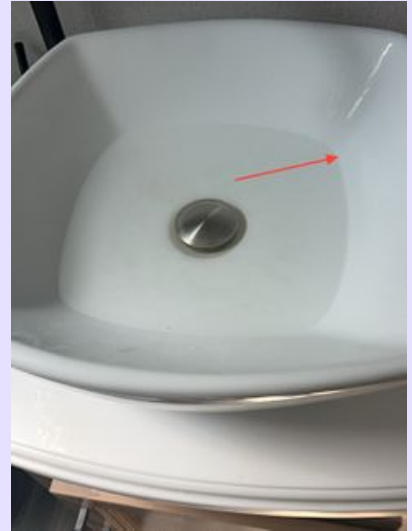
The Sink in the main bathroom drains very slowly. It is recommended that this be repaired by a qualified RV Technician.

*Main bathroom sink drains very slowly* OBJ

- ✂ **I-5 Interior - Bathroom Sink:** The Sink in the main bathroom drains very slowly. It is recommended that this be repaired by a qualified RV Technician.

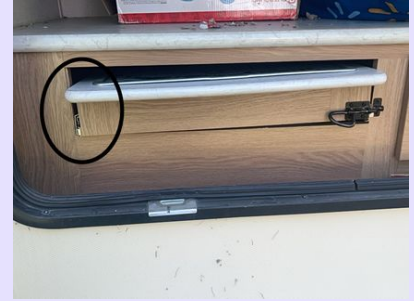
The Outside gas grill pull out shelf is off the side rail tracks and not able to pull the unit out to test it. It is recommended that this be repaired by a qualified RV technician.

- ✂ **OK-1 Outdoor Kitchen - Cabinets / Drawers:** The Outside gas grill pull out shelf is off the side rail tracks and not able to pull the unit out to test it. It is recommended that this be repaired by a qualified RV technician.
